SITE:	BIG RIVER MINE
ID:	MOD981126899
BREAK:	1.7
OTHER:	AR
5-17-88

## MEMORANDUM

SUBJECT: Recommendations and HRS considerations for the Big River Mine  
Tailing site in Desloge, Missouri  
TDD #F-07-8711-039 PAN #FM00616PA  
Site #Y60 Project #001  
Superfund Contact: Gene Gunn

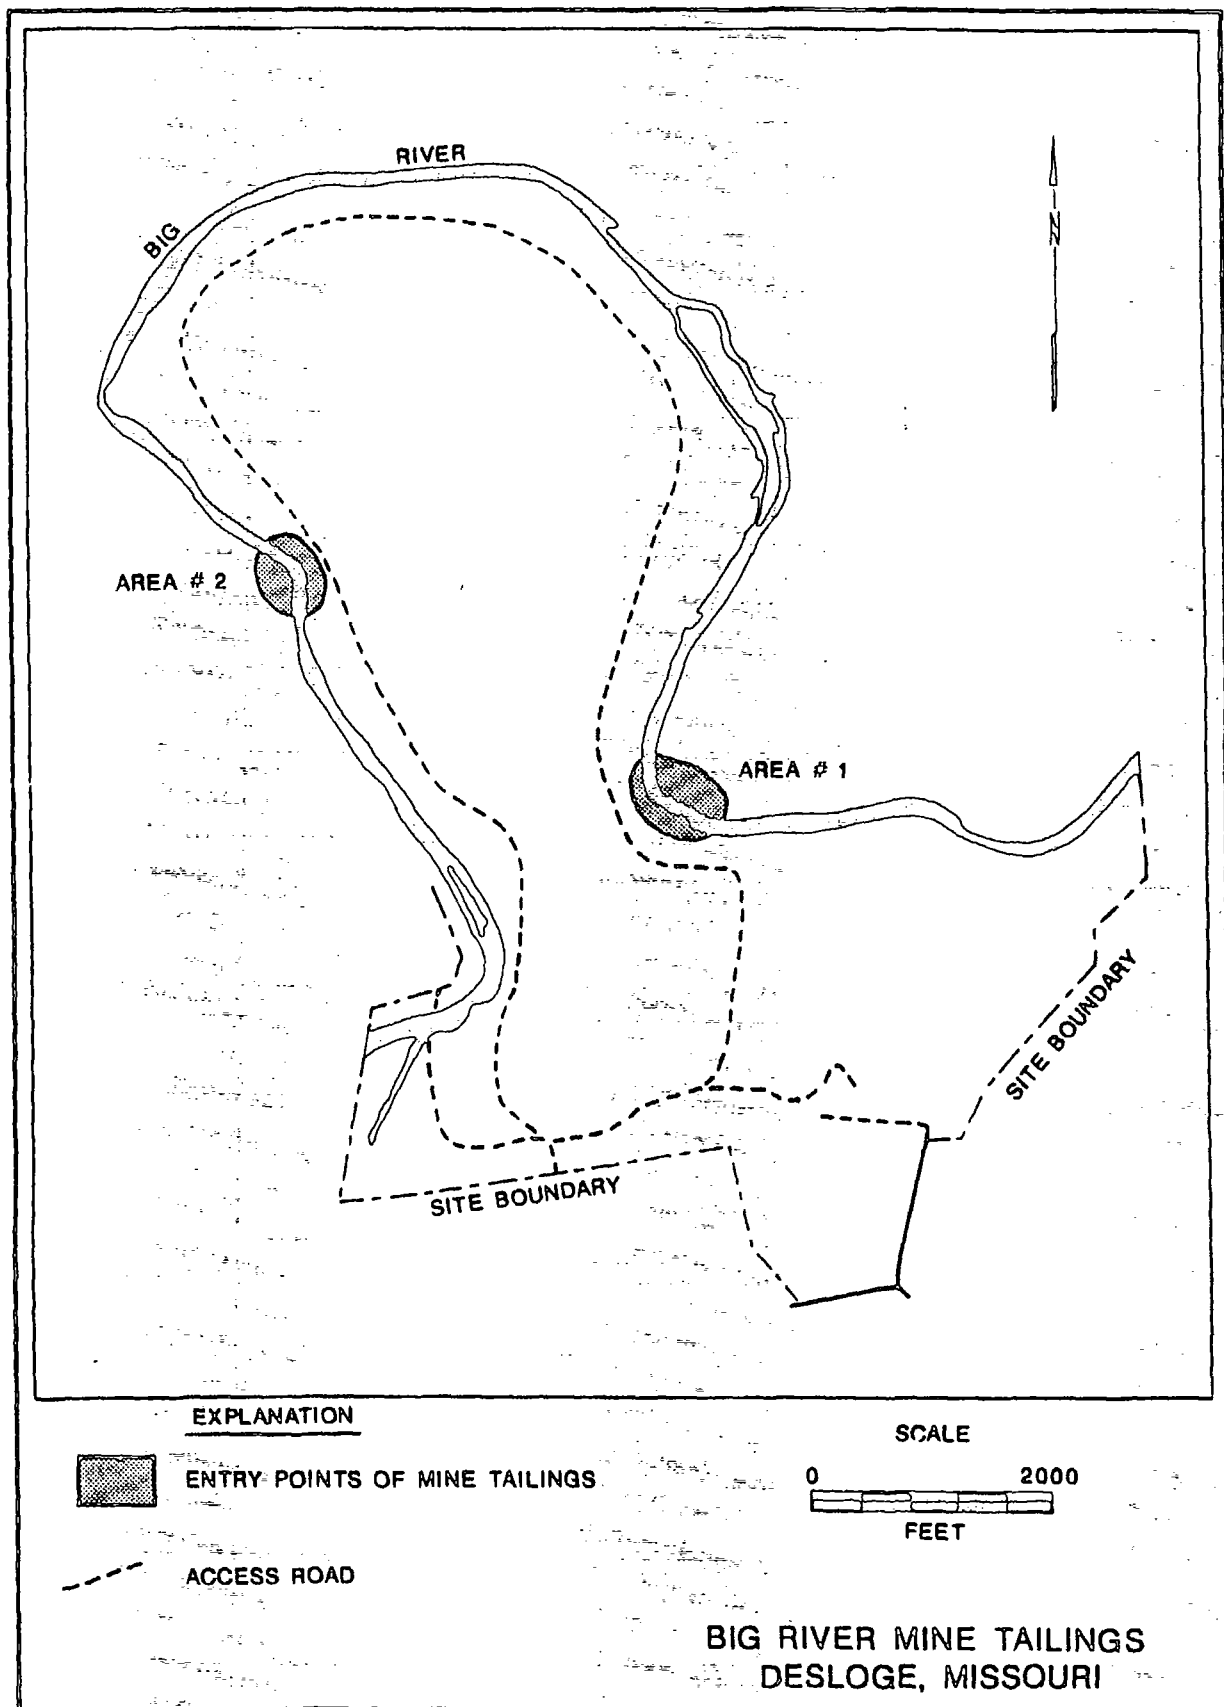
FIGURE 4: OBSERVED ENTRY POINTS OF MINE TAILINGS TO BIG RIVER

Wind erosion and the associated blowing of lead-laden dust is also a major concern (Appendix D, Photo C-1). There the tailings pile reaches the river bank in two areas (Figure 4). During the FIT reconnaissance, it was noted areas #1 and #2 that the wind was eroding the tailings over the steep incline. As tailings accumulate, and their angle of repose is exceeded, they collapse and fall into the river (Photo C-2). The major problem at area #2 is the river undercutting the bank, which eventually could lead to a collapse of the tailings in the area into the river (Photos C-12, C-13). Wind erosion is generally from west to east, which produces a continuous movement of the tailings toward the east. Because the tailings are a very fine, dolomitic sand or silt sufficient wind velocity creates a tailings dust cloud. During the site reconnaissance this occurrence was observed to be a serious problem (Photo C-1). A dust plume originating from the site was transporting dust at least one mile to the southeast. Wind speeds on that day included gusts up to 35 miles per hour.

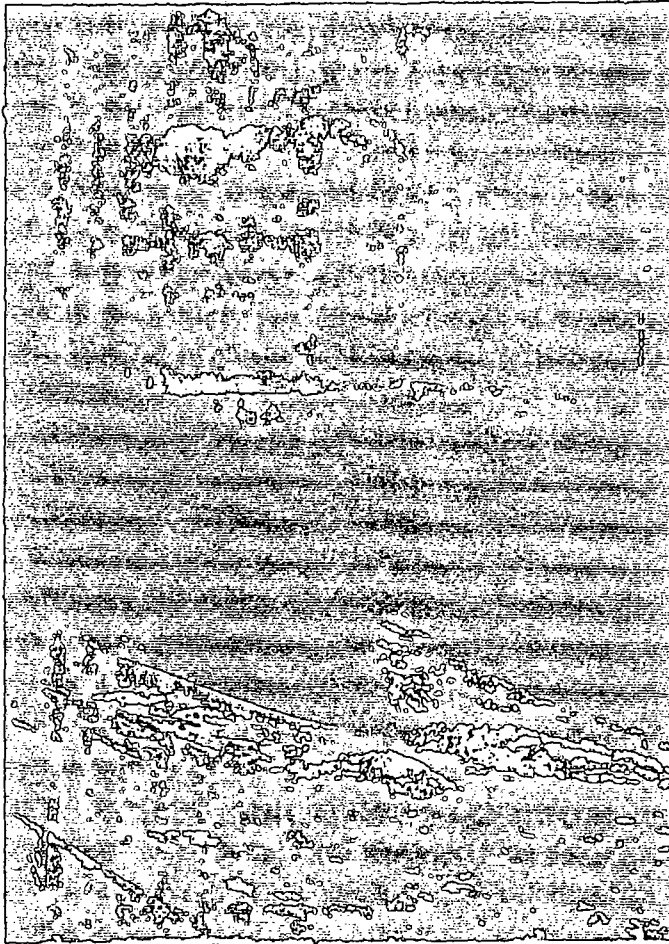
No.: C-1

Subject Big River with mine tailing dust  
rising from the pile.

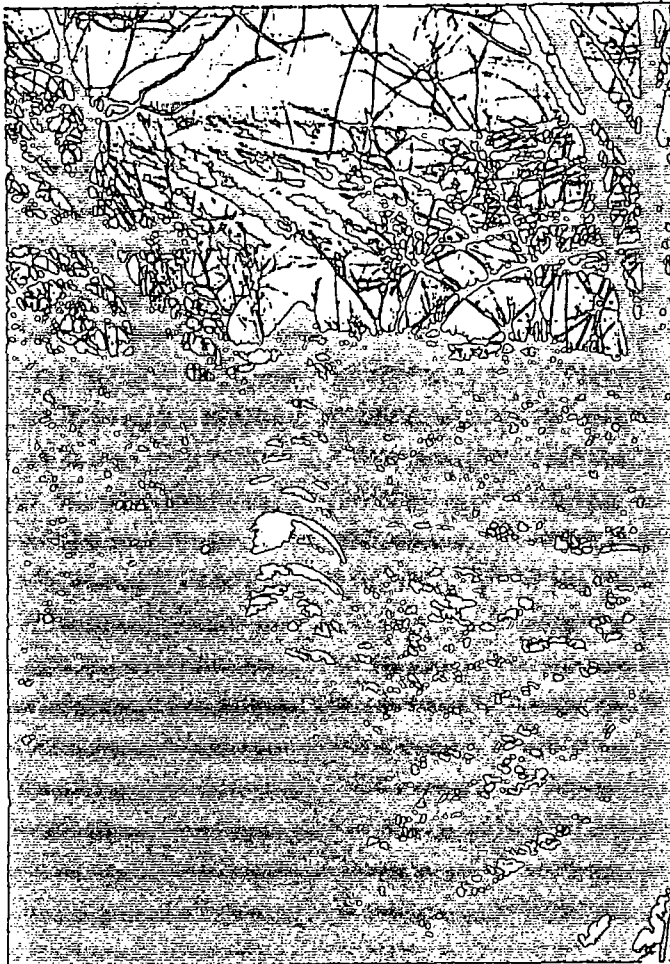
No.: C-11

Subject Gap "I" drainage pipe from  
Big River.

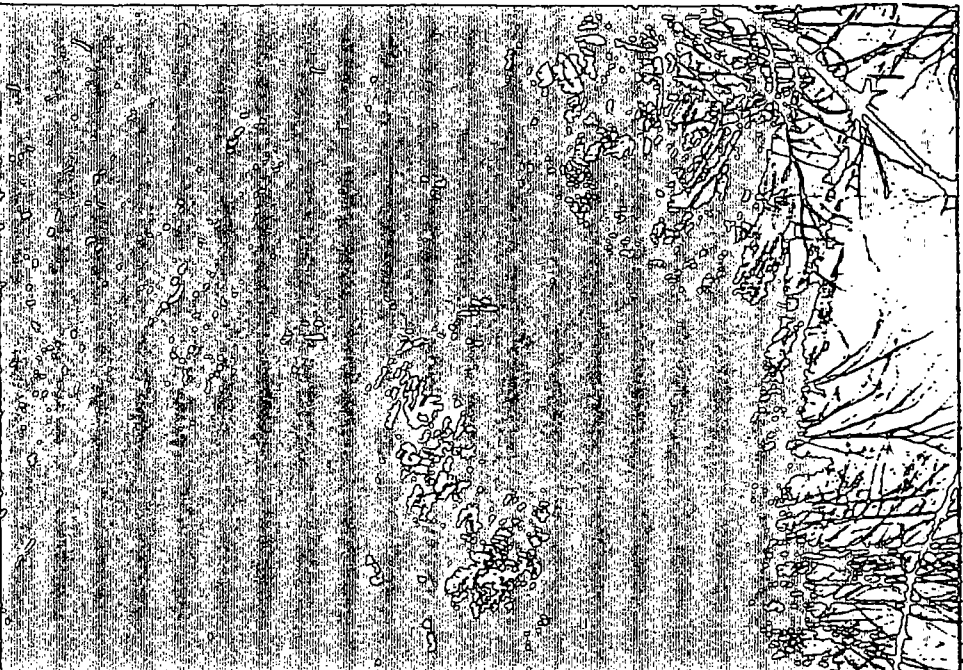
No.: C-14

The original drainage structures placed by the mining company are illustrated in Photo C-14 (Appendix D). These concrete drainage structures were constructed to drain the water from off the tailings pile. During the E & E/FIT site reconnaissance, it was noted that drainage structure #1 near Gap A was totally collapsed and was no longer functional. According to the UMC report, drainage structure #1 became blocked and this blockage led to the massive erosion which occurred in 1977 at Gaps A and B. The UMC report recommended that the major erosional gaps be filled with a suitable fill material and the area reshaped to reduce further erosion. Further, the report suggested that the drainage structure located near Gap A be altered to minimize the chance for overflow (Ref. 4).

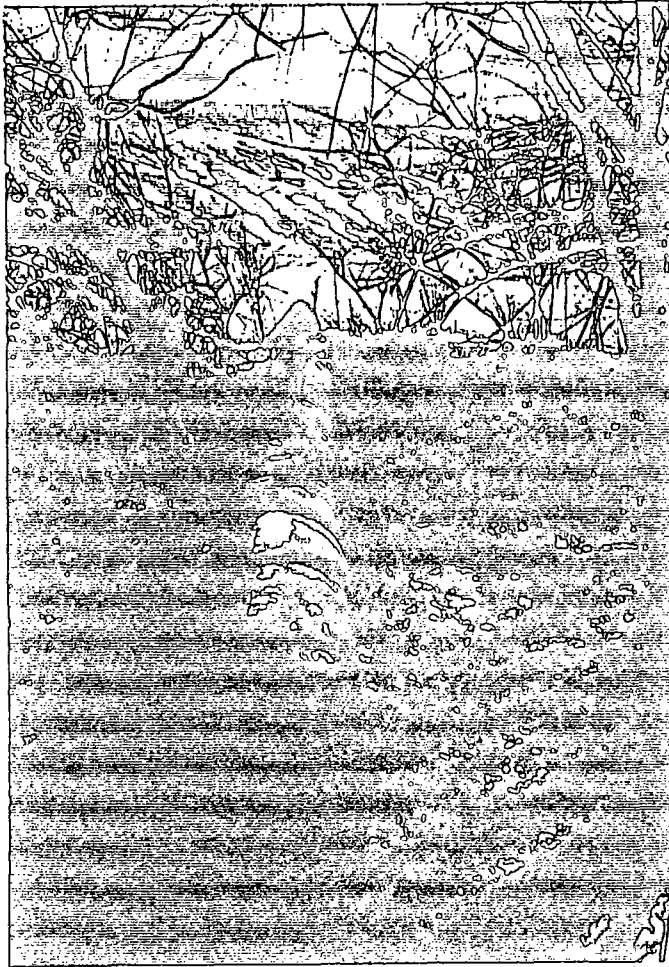
No.: C-11

Subject Gap "I" drainage pipe from  
Big River.
